DRAFT CALIFORNIA BEACH RESTORATION SURVEY 2008

December 2008

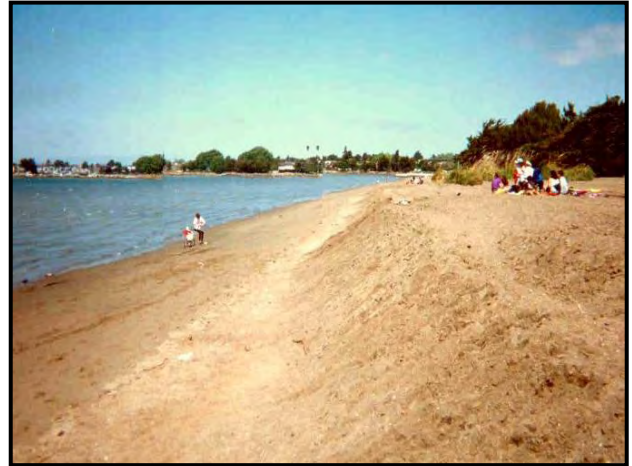
Littoral transport moves sand away from the beach and partially outside of the retaining structures, resulting in a loss of recreational benefits.

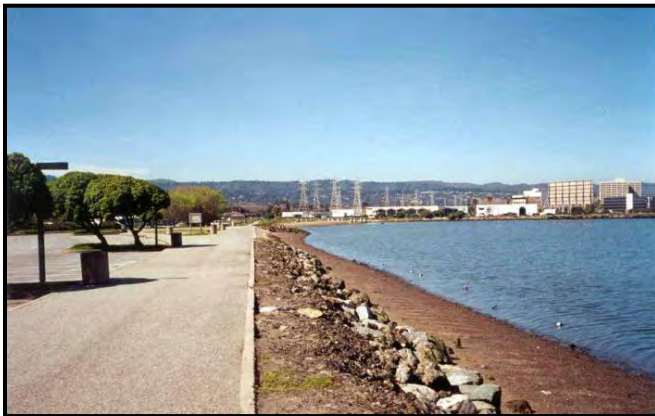
Coyote Point

Storm erosion has damaged the concrete walkway and promenade. Part of the promenade has collapsed and access to the Bay has been limited for over 300 feet of the promenade. Existing shoreline protection along approximately 600 linear ft currently protects the promenade. The remainder is unprotected and has suffered significant erosion. The area does not meet FEMA requirements for 100-year flood protection.

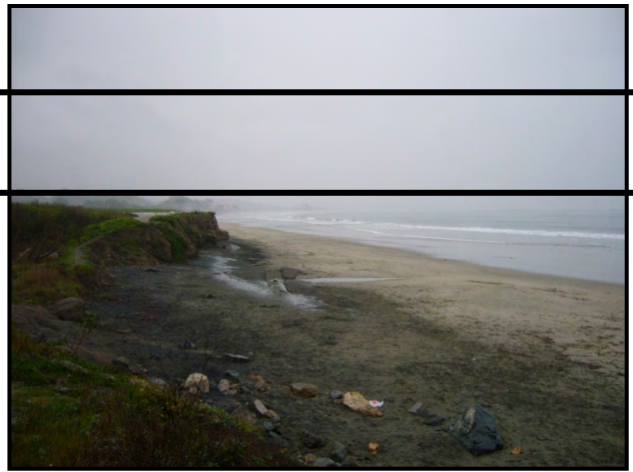
San Mateo County
Shoreline Mile 20
List Source- Survey

High beach usage/access area. Erosion of the bluff occurs during high tides and storm wave activity. Erosion has undermined the parking area and threatens a wetland behind the former parking area. Undermining of Highway 1 is imminent- some revetment in place to forestall such erosion.

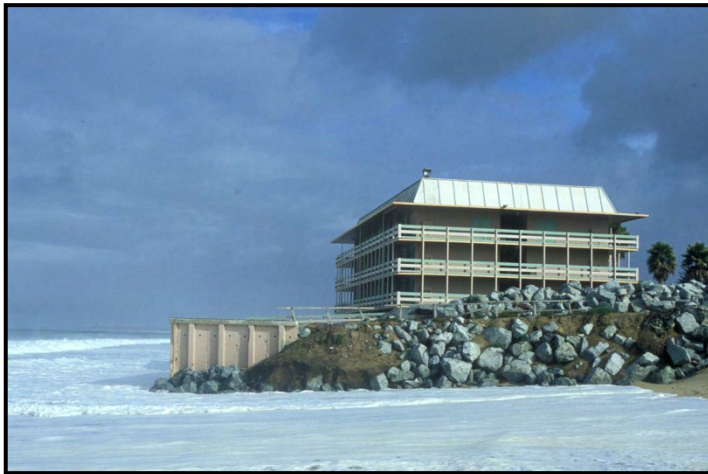
Southern Monterey Beaches

Rapid erosion of the beach and coastal dunes are impacting critical habitats, coastal access, and threatening public infrastructure such as a raw sewage transport trench. Passive erosion fronting areas of hardened shoreline will eventually prohibit lateral beach access through narrowing of the beach. Seawalls continue to be built to protect individual structures from erosion-related damages. A 3-mile stretch of shoreline from Wharf II north to Sand City recommended for restoration in the CRSMP. CRSMP indicates erosion rate of 1.0-3.5 ft/year along this stretch.

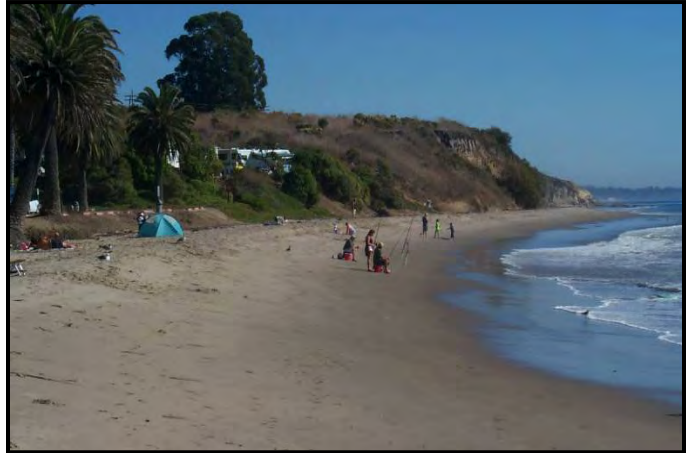
Existing beach is inadequate in width and berm height during winter months to fully protect back beach area from storm waves and coastal flooding. Palm trees are in eminent danger of erosion damage. Erosion results in recreational loss during summer season.

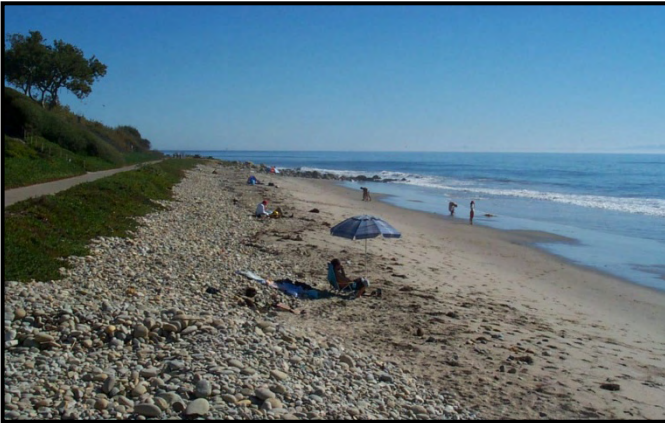
El Capitan State Beach

Existing beach is inadequate in width and berm height throughout the winter months to fully protect cliff toe and backlands from storm waves and coastal flooding. Existing restroom building is partially protected by retaining wall structure. Exposed cobble in winter provides some erosion protection.

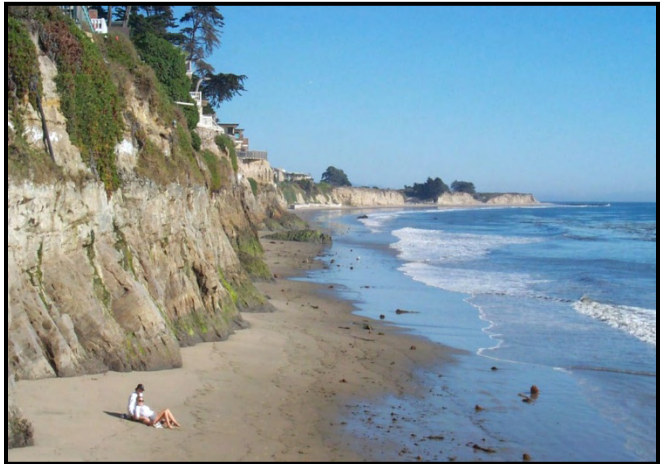
Existing beach is inadequate in width and berm height throughout the year to support recreation use. Sea cliff toe is continually exposed to waves which threatens development and infrastructure. This is a potential feeder beach for Goleta and other downcoast beaches, which could increase the project benefits beyond that determined for the individual location.

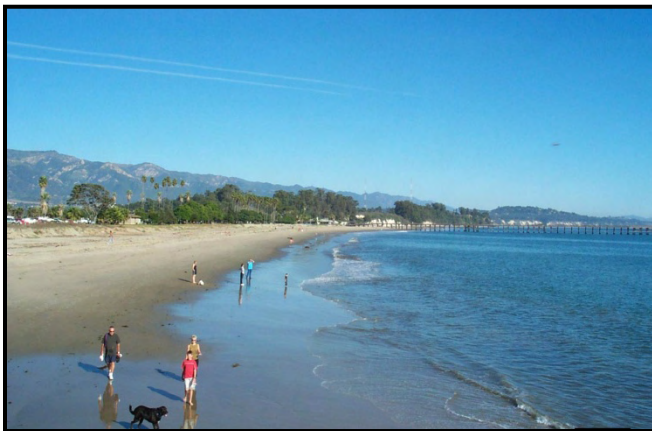
Goleta Beach County Park

Chronic erosion has resulted in loss of recreational beach and damage to park improvements. Beach was renourished in 2004. this area is part of an ongoing USACE shoreline protection study.

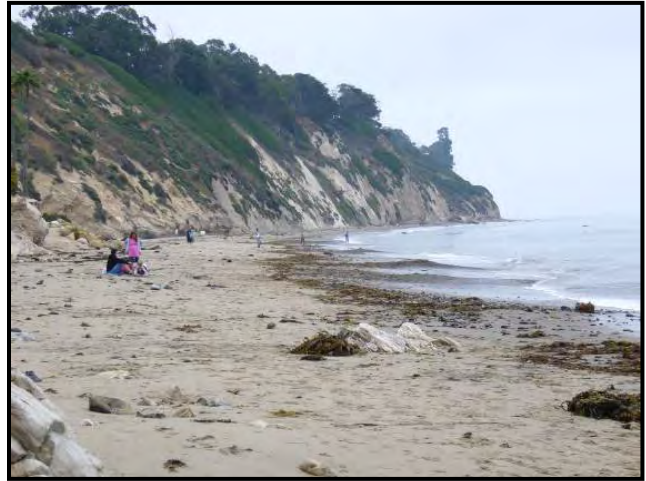
Wave-cut bluff produces frequent slides along base and face of bluff. Park facilities and coastal access stairways subject to damage from high waves and flooding.

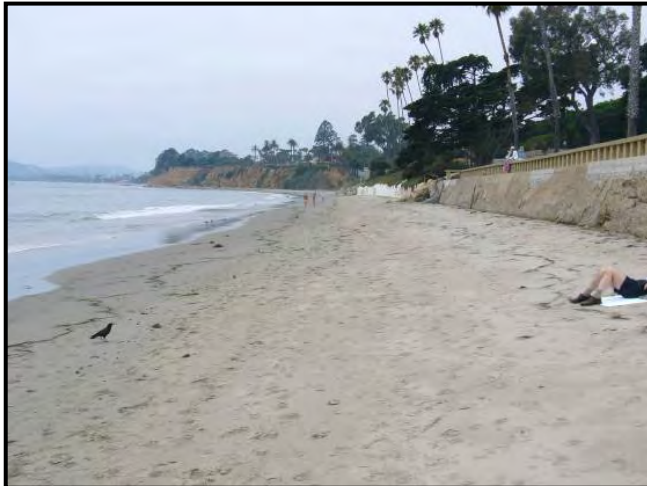
Butterfly Beach

Bluff contains many active slides, and road is threatened by cliff erosion. Low lying areas behind street are subject to flooding during high wave conditions.

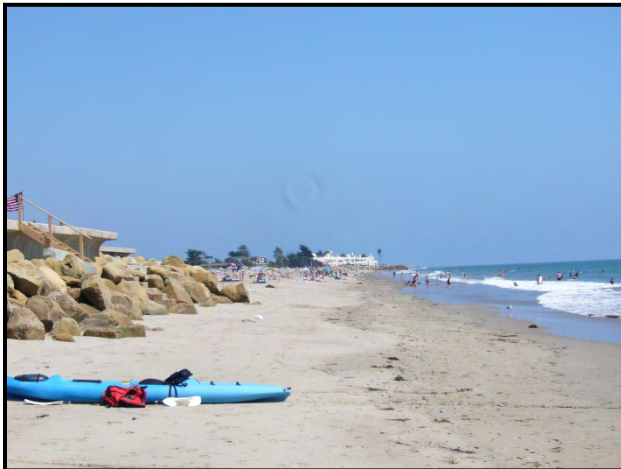
Santa Claus Beach

Houses and railroad are subject to flooding and damage during high storm events.

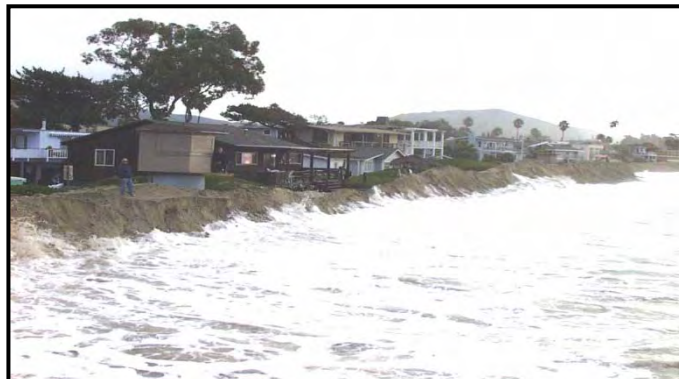
This beach is highly susceptible to storm erosion and resulting damages. The continued erosion of the beaches will further reduce the already limited recreational spaces on the beaches. Damages to the private property and public facilities will continue as a result of shoreline retreat, storm damage, and coastal flooding USGS reports long-term trends of erosion to west, accretion to east; Erosion hotspot migrated onto beach during 97-98 El Nino with erosion rates of 0.3-2.33 m/year. This area is part of an ongoing USACE shoreline protection study.

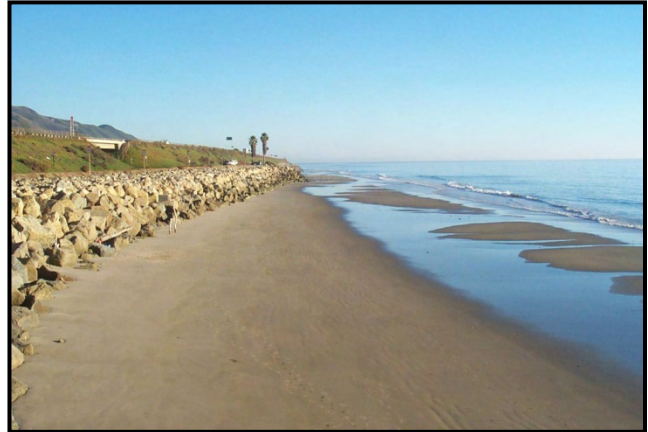
The rock revetment-backed beach at Oil Piers has narrowed in recent years due to demolition of the Mobil oil pier in 1998. Shoreline erosion between the demolished oil pier location and the shoreline has increased since removal. A sand retention structure, or multi-purpose reef, located offshore is proposed for this location by USACE. The main goal of the reef is to retain sand that will be placed along the shoreline, without having a negative impact to the adjacent shoreline. The reef is also designed to enhance natural resources and recreation opportunities (i.e. surfing) as additional benefits.

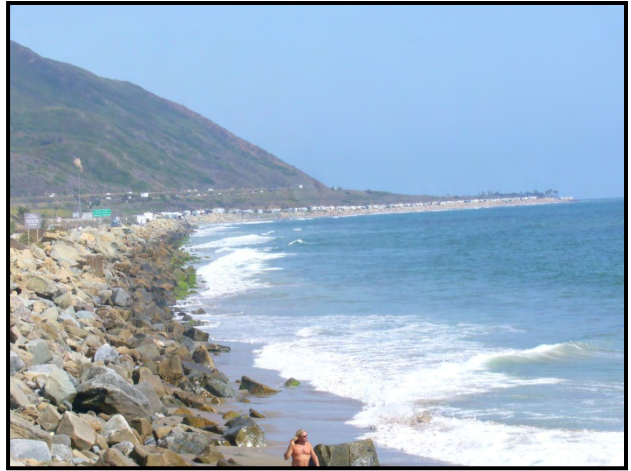
Road subject to damage during high wave conditions from wave overtopping

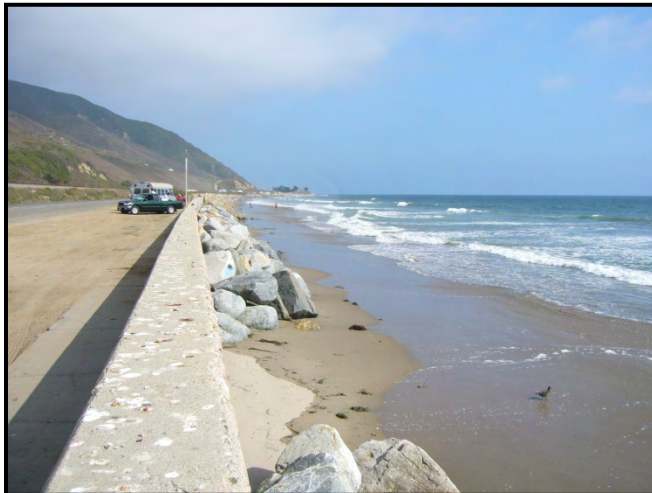
South Rincon Parkway/Emma Wood County Beaches

Setting: Narrow sand and cobble beaches backed by rock revetment, deteriorating concrete seawall, Highway 101 and homes. Emma Woods State Beach is located at south end of the Parkway.

Road and homes are subject to flooding and damage from overtopping waves during high storm events.

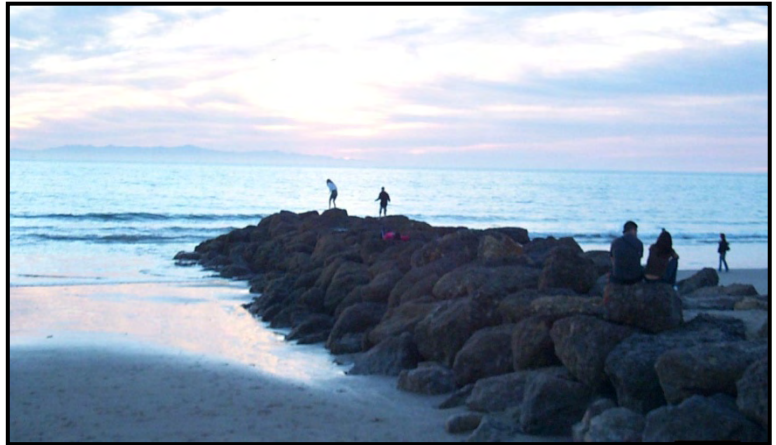
Six rubble-mound groins built in 1960's are in need of maintenance and rehabilitation to maintain function and prevent shoreline from receding.

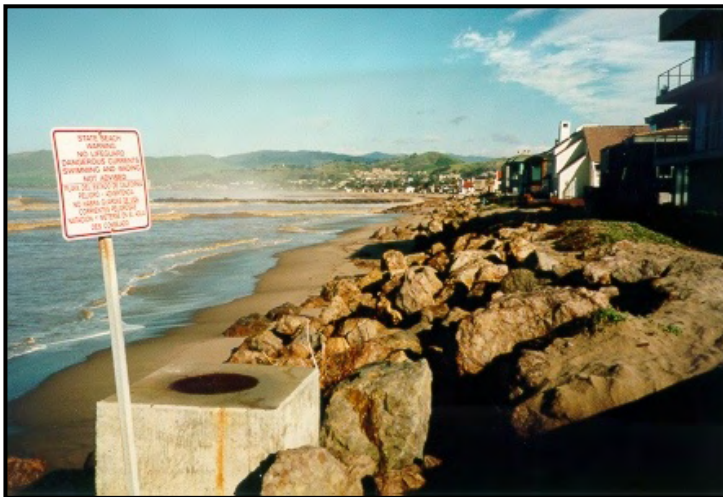
Pierpont Beach
Ventura County
Shoreline Mile 15.6-15.8
List Source- Survey; CRSMP

Beach is chronically narrow at terminus of groin field and harbor jetty. Recreation opportunity exists by virtue of lateral access. Wind-blown sand creates a nuisance hazard.

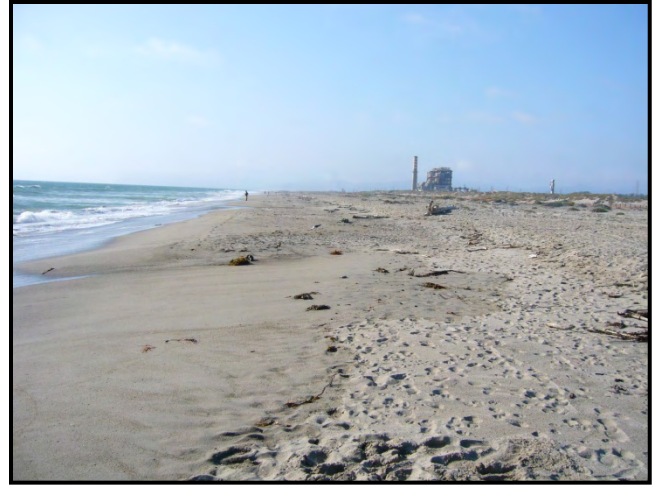
Beach subject to extreme changes. Wind-blown sand creates a nuisance hazard.

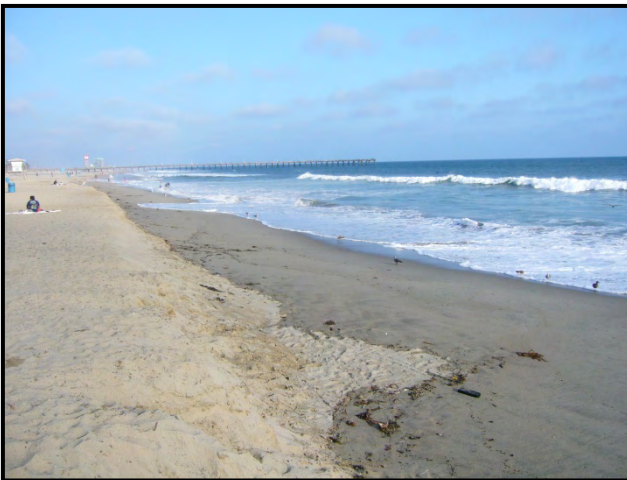
Hueneme Beach Park

Park facilities subject to damage during high wave conditions. Nourishment location and placement needs to be optimized to enhance longevity of sand on beach before it is lost down Mugu submarine canyon.

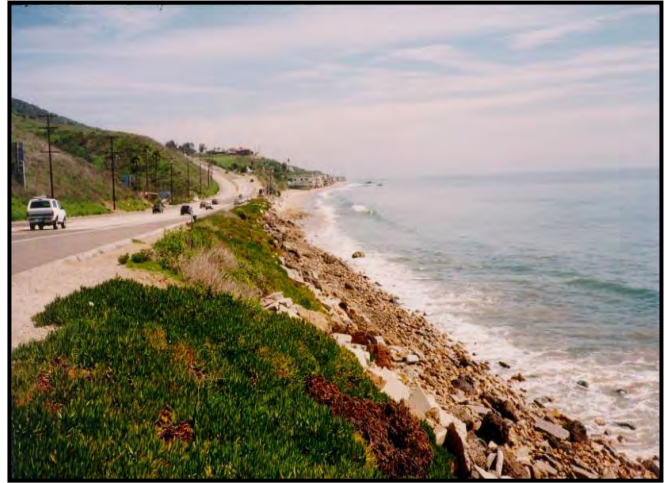
Beach is inadequate in width and elevation to fully protect highway from severe storm flooding episodes. Natural outcrop at downcoast end of beach is insufficient to act as retention structure. Need to improve recreation opportunities, and protect recreational facilities and infrastructure.

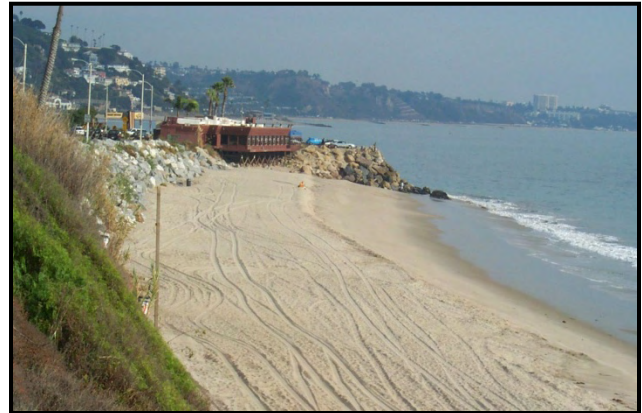
Lifeguard headquarters building is in jeopardy of storm flooding and erosion damages. Shoreline is relatively stable at mouth of Topanga Creek due to cobble armored nearshore. However, artificial headland at east end of beach segment is inadequate in width to retain sand within the pocket.

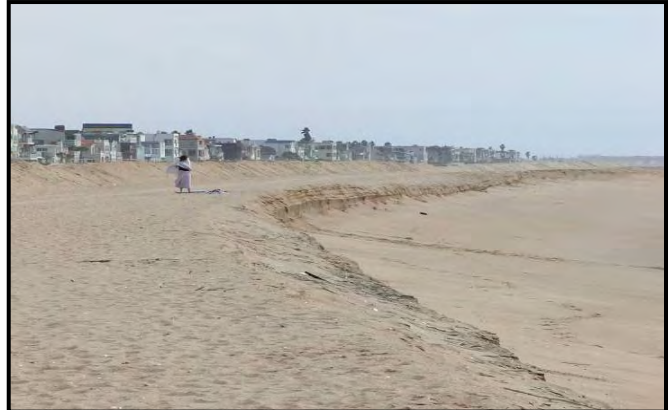
Chronic erosion due to the construction of the Anaheim Bay Jetties has resulted in loss of recreational and protective beach from lack of long-shore transport. Houses are subject to severe damage if beach is not nourished periodically. Periodic renourishment since the 1960s utilizes this area as a feeder beach for downcoast beaches within the San Pedro Littoral Cell, providing shoreline protection, recreation and tourism opportunities, public health and safety benefits, and will enhance downcoast coastal habitats.

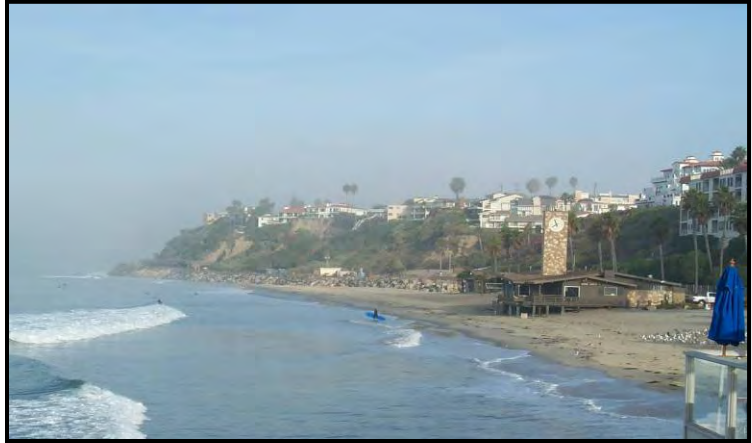
Loss of shore protection and recreational beach width is a continuous problem for the City of San Clemente. Damages to coastal, residential, and commercial properties from storm-induced waves have become a serious threat. Railroad is often overtopped and damaged during high wave conditions. Coastal Commission staff have estimated erosion rate of 0.12 ft/year (with update noted as needed).

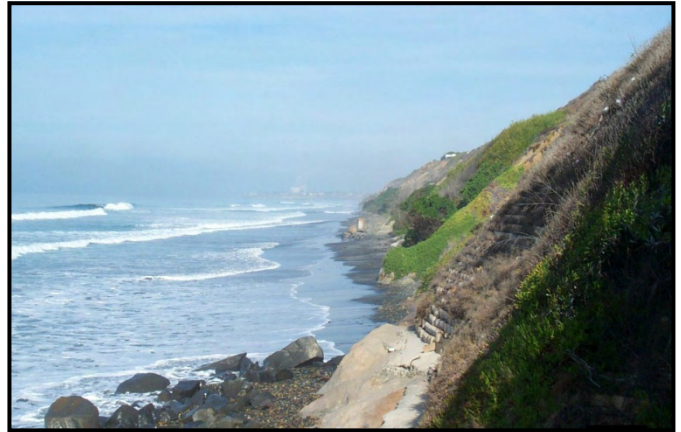
Cliffs are susceptible to landslides and erosion during high wave conditions. Beaches have never fully recovered from subaerial sand losses associated with the 1982-1983 winter storms. Beach areas provide recreation and tourism opportunities, public health and safety benefits for the city and its visitors, and coastal habitats are in need of enhancement.

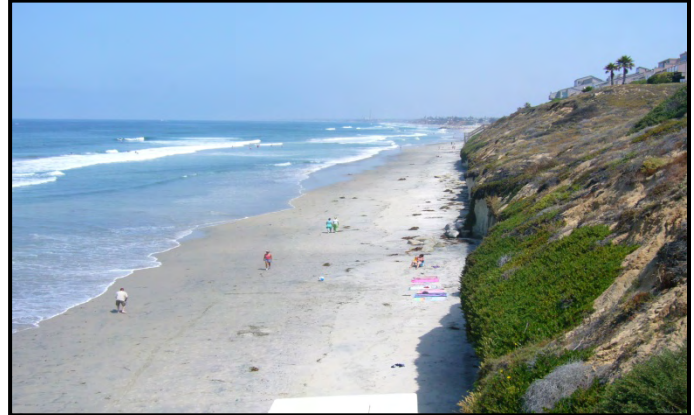
Wave induced erosion of cliffs is threatening cliff edge development. Cliffs comprised of poorly to moderately consolidated sandstone standing near its stability limit and subject to landslides. Coastal Commission staff have compiled erosion rates of 0.15 ft/year(Ponto Beach); 0.5 ft/yr(Leucadia Beach). This area is also within an ongoing USACE shoreline protection study.

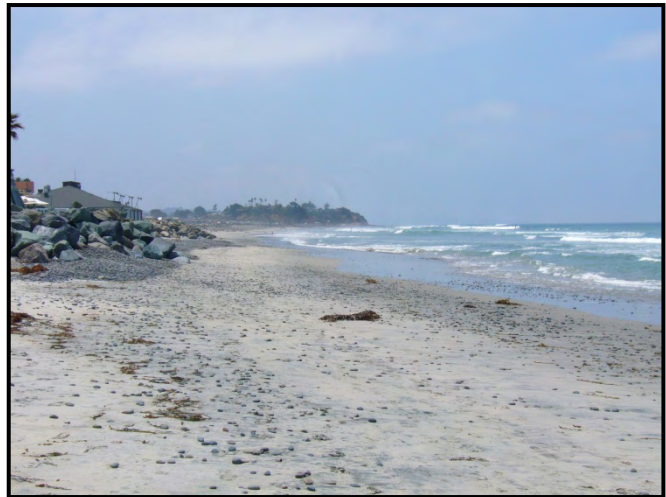
High waves strip sand away, exposing cobbles and protective rip rap.

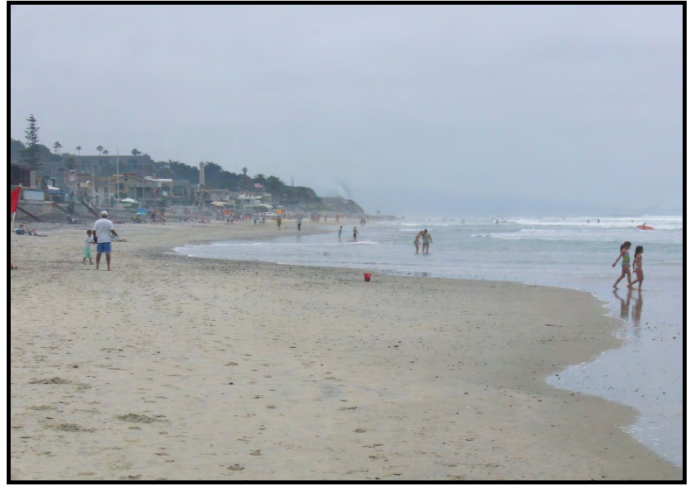
During severe winters, protective beach is eroded and development behind the City beach is subject to flooding and damage. Location is heavily armored, but is often subject to damage and overtopping. Spit susceptible to wave overwash and some streets may also be flooded by San Dieguito River.

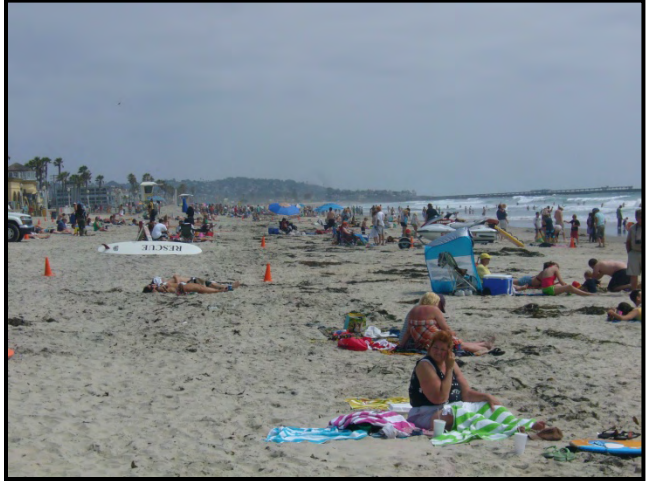
Mission Beach is overtopped during certain storm wave events, such as winter storms of 1982-1983 and 1988. The littoral cell is losing small volumes of sand over time with little or no natural sand inflow, and relies on nourishment to maintain its condition. It is a historical sand placement site for the US Army Corps of Engineers and would be suitable for receiving more sand in the future.

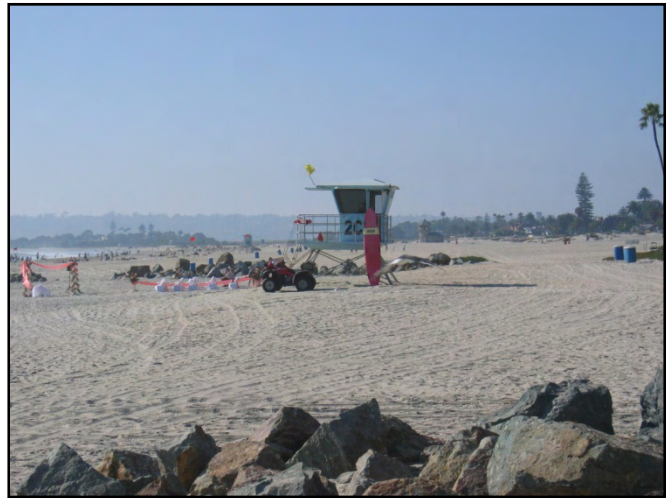
Coronado's beaches vary in width throughout the City and are narrowest in front of the Coronado Shores. The beach can be completely absent during winter storm wave conditions. The City desires to maximize project with nourishment.

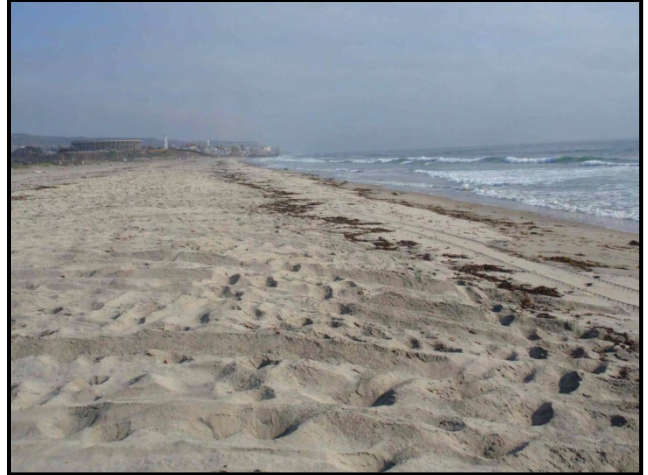
Area is subject to flooding and damage during high wave conditions, including clogging of estuary channels. Sand shortage is caused by dams located on the Tijuana River. Modeling indicates breaching of dunes protecting estuary from salt-water inundation could occur by 2045 if dunes/beaches are not restored. This is the location of a demonstration project (Tijuana Estuary Sediment Study) to assess whether sediment with high percentage of fines can be placed in nearshore without adverse biological effects and whether incidental beach and dune nourishment effects are observed as a result of such placement.
